HERITAGEWORKS

23-01-2023

UH0143 - Hedley Mascot Mine, Progress Update

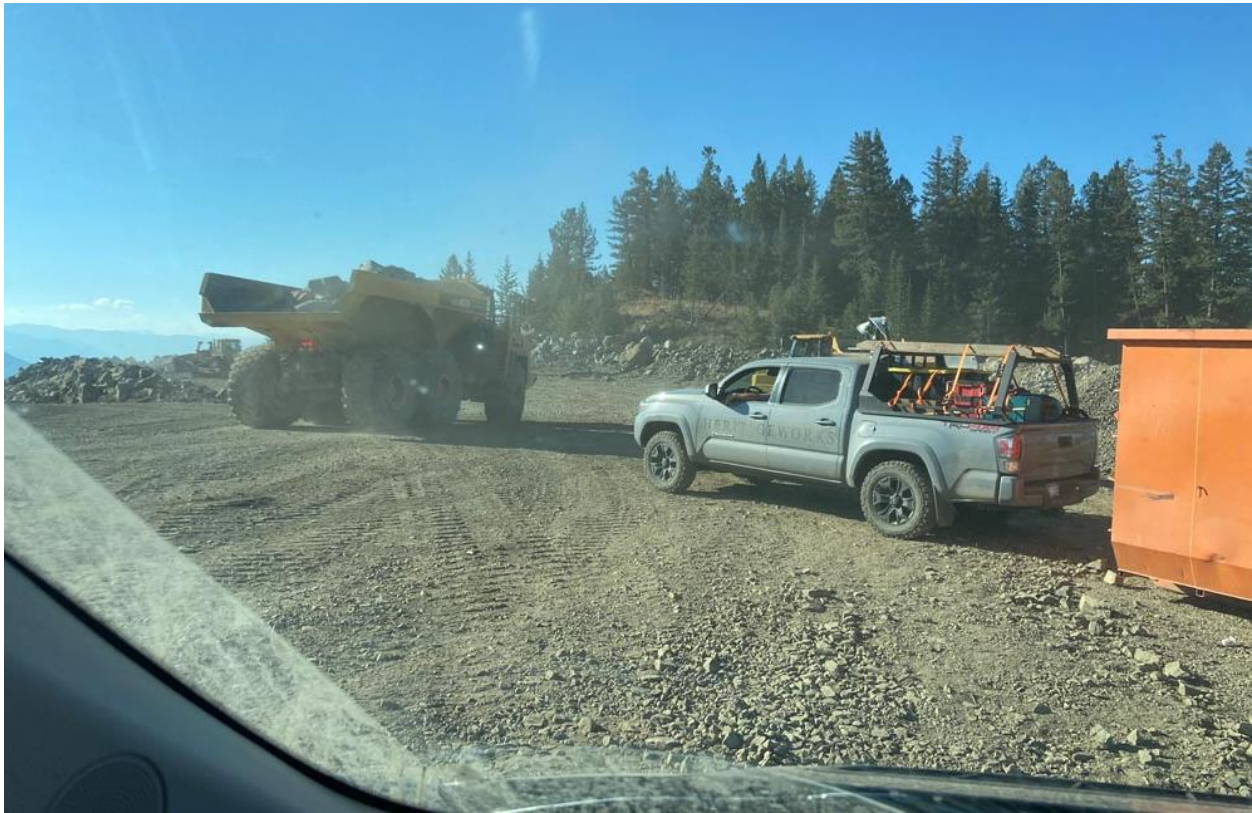
Figure 1 – Barrick Nickle Plate Mine site with major construction work underway at access road into the mascot Mine Site.

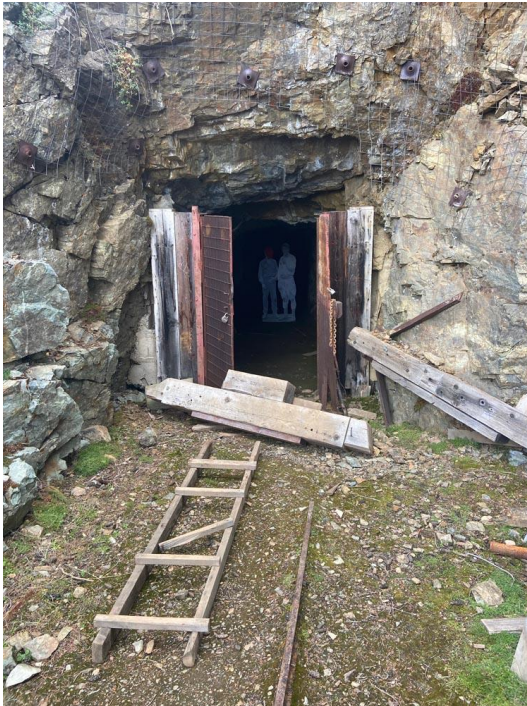
Prior to arriving on site, the historic structure of portal number 1 had been vandalized and pulled apart by people trying to access the tunnel. The two gates were broken open and one deformed to the point that it could not be used.

Figure 2 – Portal Number 1 with damage sustained over summer months.

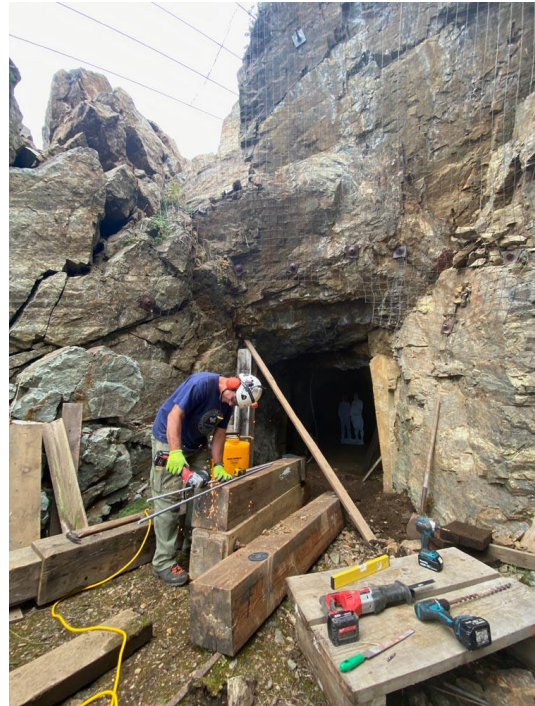
Figure 3 – Our repair required that we dismantle the remains of the existing structure, prepared the ground for the repair, and then assembled new timber to build a reinforced structure.

Our repair was based on a design focussed on reinstating the historic elements of the portal in their historic configuration, but with the addition of a bunch of supplementary structure to make access to the tunnel very difficult. For material we used timber that has previously been stored on site for some time and which was surplus to previously repair campaigns.

The new portal design reduces the gated opening to a single “man door” though which a wheelbarrow or stretcher can pass freely, but which reduces the opportunity for vandals to get a purchase on the door to pry it open. The portal structure was made up of 10”x10” Douglas fir timbers with structural screws connections. The timber frame structure was then clad on the exterior with 3” planks of varying thicknesses, also held in place by structural screws. These planks were fit with a tight scribe to the surrounding rock to prevent prying. To the inside of the frame, we lined the portal wall with steel mesh with backing planks to prevent vandals from cutting though the plank and frame.

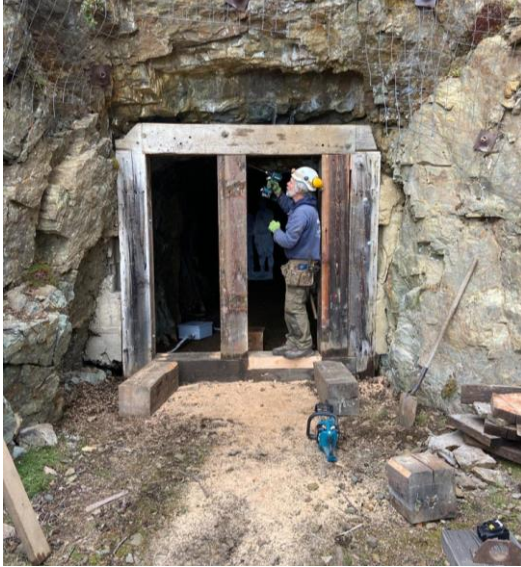
Figure 4 - New heavy timber frame.

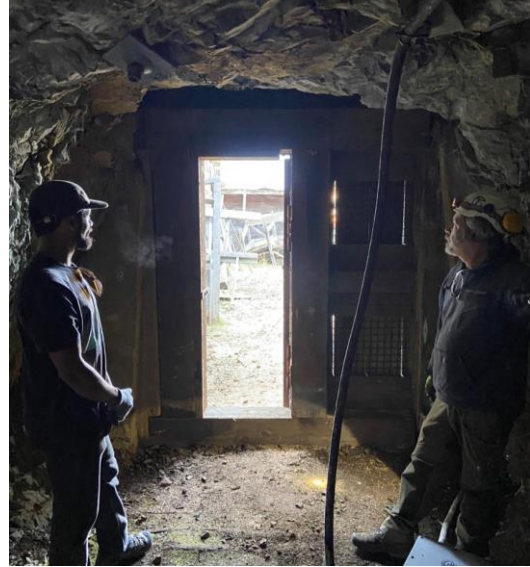
Figure 5 - New structure from the interior with steel mesh shown in the shadows on right side of frame

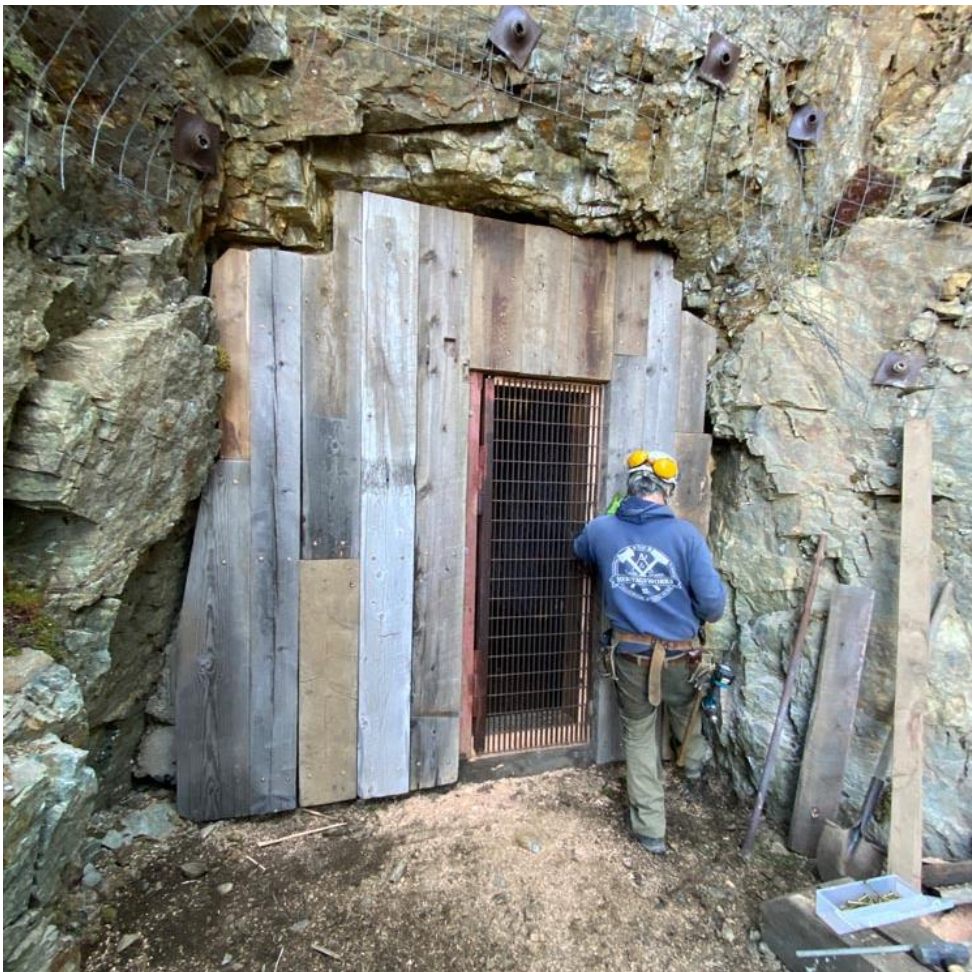
Figure 6 – New Portal Number 1 with 3" plank cladding.

One of the original gates was rehung, and we fabricated a new lock mechanism to secure the gate with a motorcycle lock. Finally, we posted signage to warn visitors to not attempt entrance the tunnel.

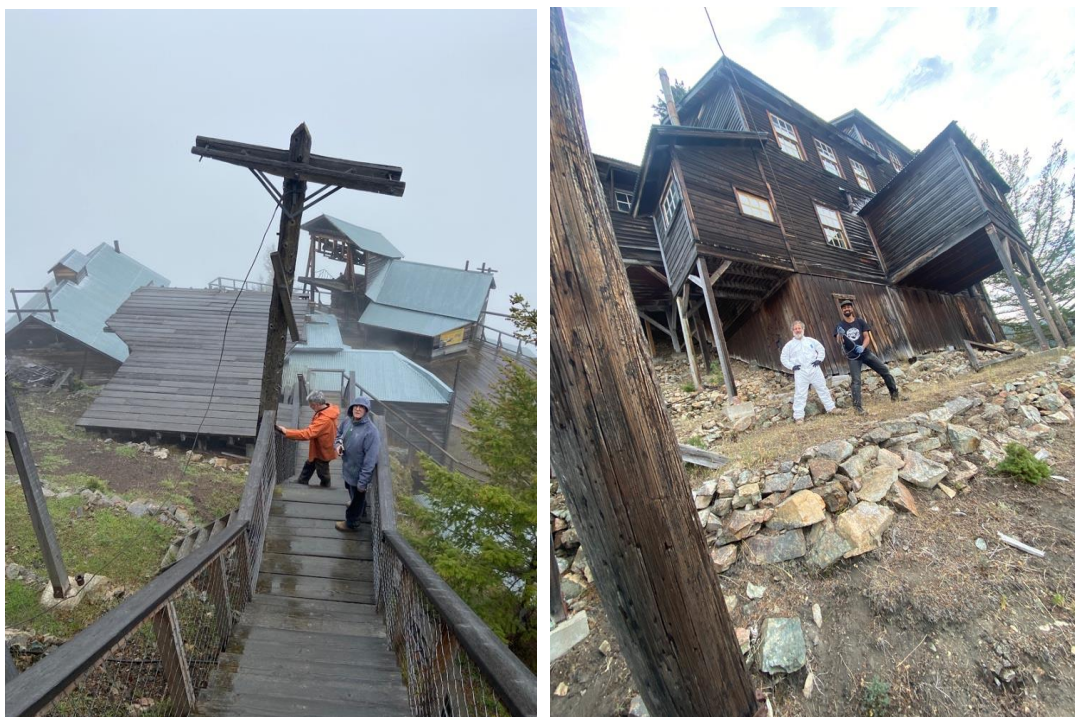
Of the system of electrical services that supplied power to most of the original buildings there is one surviving wooden power pole. This is located below the cook house and above the modern helicopter pad and over the summer its rotten base finally gave way, allowing the pole to lean dangerously against the stair. This presented a risk to visitors to the site, but also to the adjacent buildings, and we came to site with the necessary equipment and rigging to lower the pole safely.

Figures 7&8 – Electrical pole surveyed in late summer and lowering the pole during our most recent phase of work

Having lowered the pole, we set it on the terrace below the cook house for re-erection in a future phase of work.

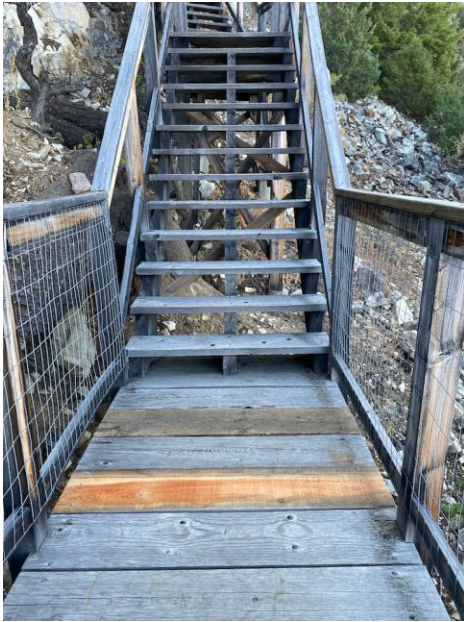
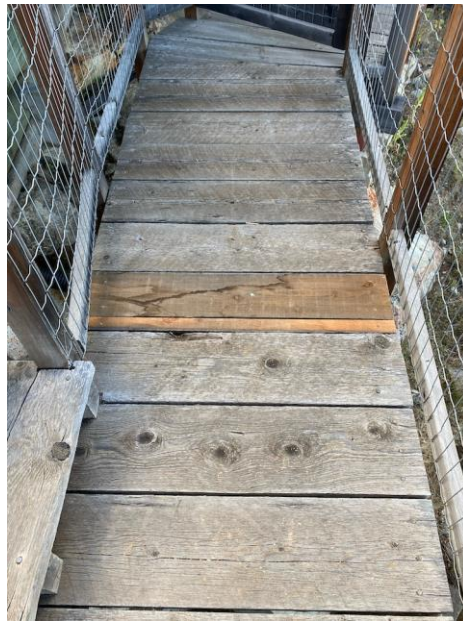
Over the past year the access stairway has suffered from extensive localized wear on stair treads with some individual stairs and 2" landing boards cracked or snapped. On the decks of the washhouse, cookhouse, and main level several of the decking planks have popped nails or have worked themselves loose. Both of these conditions are the result of the harsh site environment and the ageing timber elements that the site is constructed from.

Figures 9&10 – Stair landing repairs

Therefore, a primary aim of the aim of this year's preparation of the site for winter was to systematically go over all these problem areas, making repairs of broken elements, and refastening loose or popped boards and rehangng gates with new hardware. The work was spread across the site from the observation deck at the tip of the access stairway to the main level deck.

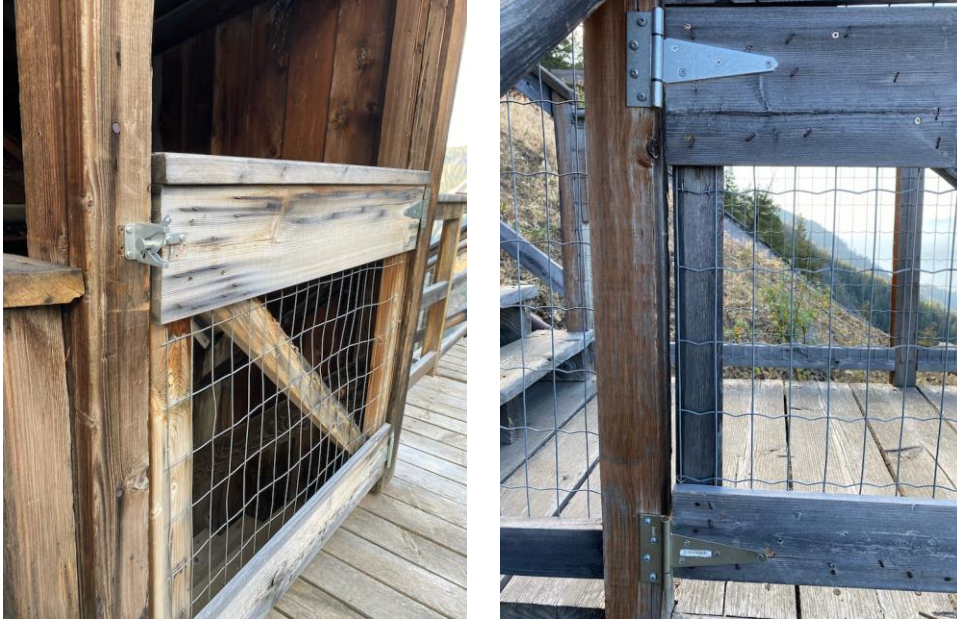
In another category, several of the repairs to gates and railings that we did last year have been vandalised and required repair. It is our view that the regular repair of these areas and the

Figures 11&12 – new hinges and latches on gates that had been ripped off their mooring

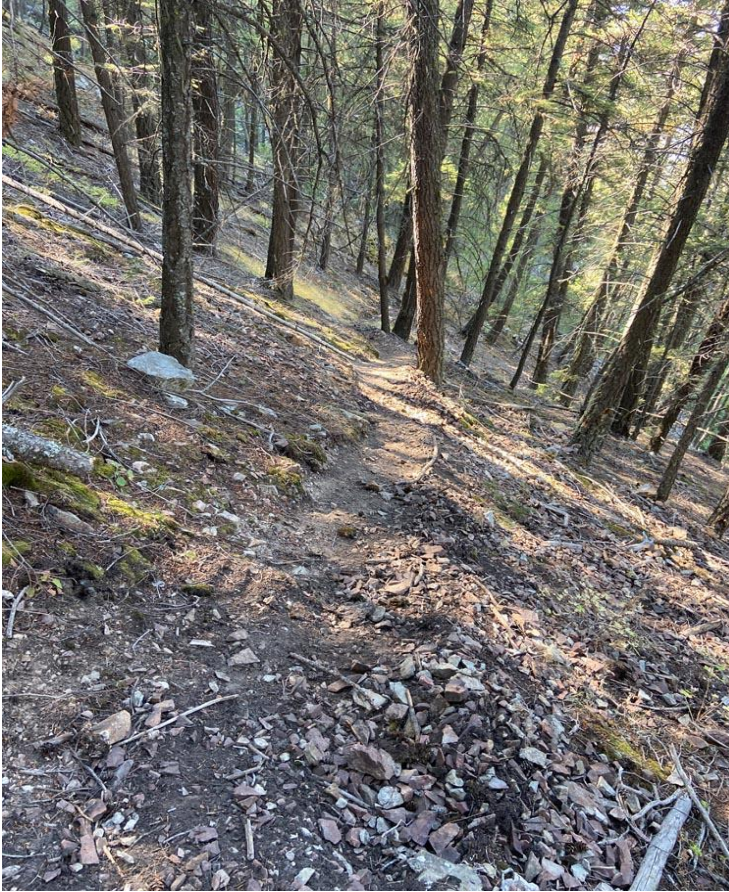
The route is steep and forested, but visitors to the site have previously been starting an informal trail along this route. It is our intention to formalise this trail, making it more accessible than it currently is and to use mostly material that can be found on site to do so.

Figures 13– Steep section of existing trail connecting Princeton Mine road and Mascot Mine road

This year, we mapped the route with GPS and surveyed a new route for the trail.
